**CONNECTICUT RIVER BASIN
PLYMOUTH, VERMONT**

**WOODWARD RESERVOIR DAM
V T. 00209**

**PHASE I INSPECTION REPORT
NATIONAL DAM INSPECTION PROGRAM**

MAY 1979

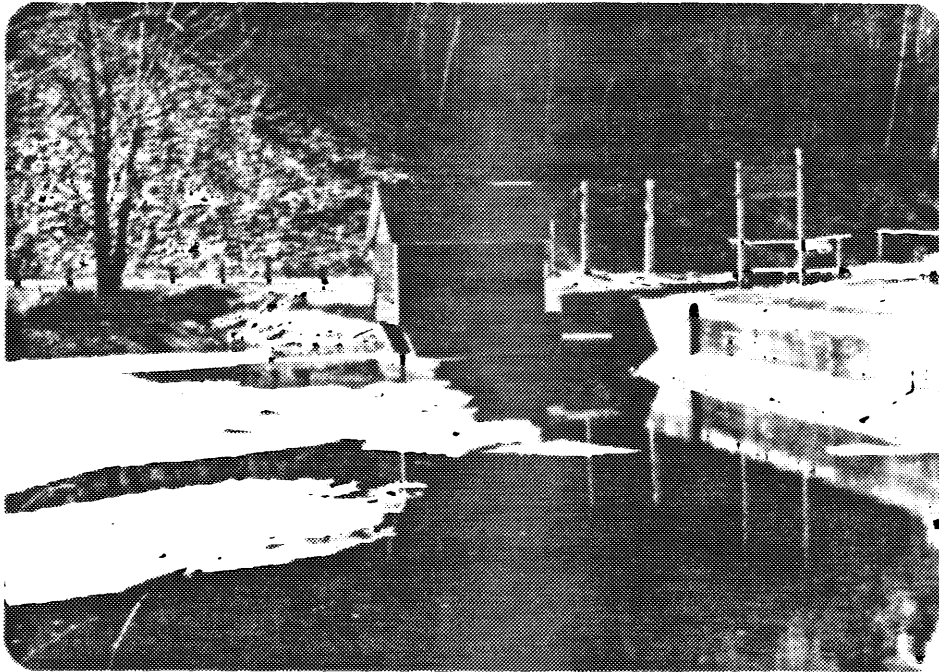
The condition of the concrete is fair with spalling occurring particularly at construction joints. Some erosion has occurred at the left and right abutments as shown in Photos 1 and 5. According to the Plant Manager, Bruce Nelson, this happened during the 1973 flood.

#1. VIEW FROM RIGHT ABUTMENT SHOWING GATE HOUSE

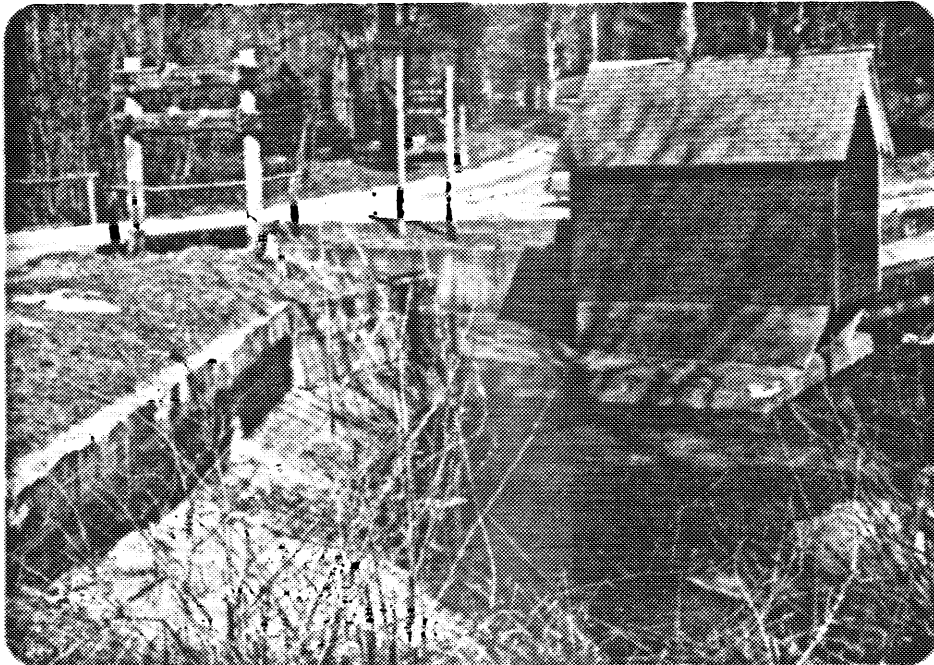
The concrete emergency spillway is located in the center of the dam and is 13.9 feet wide (Photos 2 and 3). Over it sits an access bridge (See Photo 4). The distance between the spillway floor and the I-beams of the bridge is 3.5 feet. The spillway floor and walls are in good condition. One crack has developed in the right spillway wall and spalling has occurred along the top of the walls and several other locations. On the upstream end of the spillway are two concrete abutments which allow for the placement of 2-feet of stop logs. The stop logs are placed diagonally between the end of the spillway and the back of the gate house. The downstream vertical face of the

#2. VIEW SHOWING LEFT ABUTMENT, GATE HOUSE, SPILLWAY AND ACCESS BRIDGE

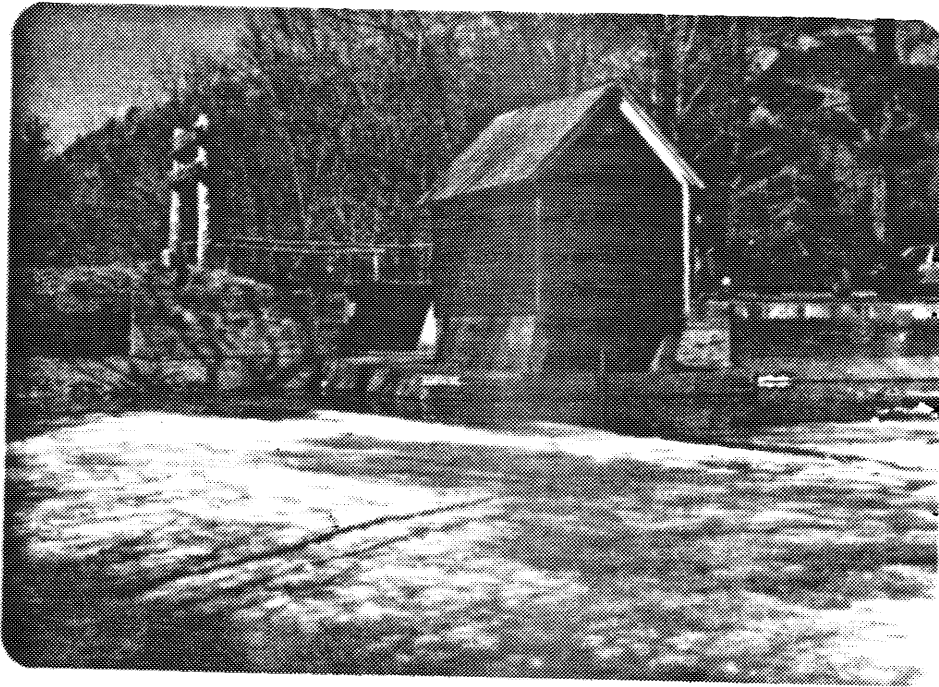
Upstream of the spillway sits a gate house elevated above the spillway floor slab by two concrete supporting walls (Photo 3). The gate house provides control of a 2-foot square stone low-level outlet. According to the Plant Manager, the low-level outlet has a log bar screen on the intake. The inlet was under water and not visible during the inspection. The gate is in good working condition and was operated easily during the inspection. The stem had to be repaired in April of 1978. The downstream end of the low-level outlet has been severely scoured (see Photo 6) and with the added effect from the emergency spillway directly above, has started to undermine the dam.

#3. VIEW SHOWING GATE HOUSE, SPILLWAY AND BRIDGE

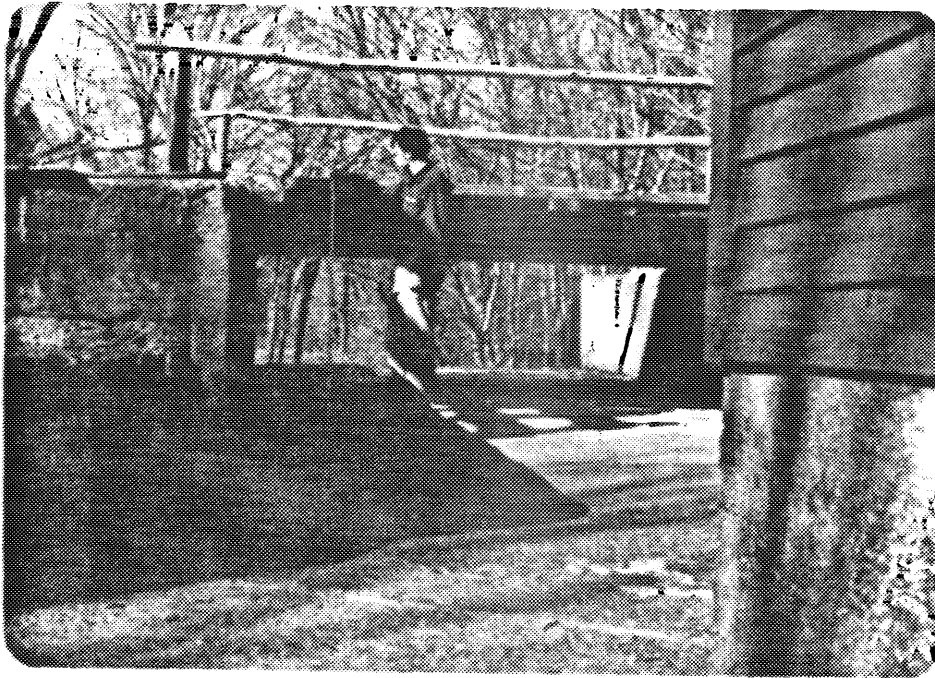
#4. CLOSE-UP OF SPILLWAY AND ACCESS BRIDGE

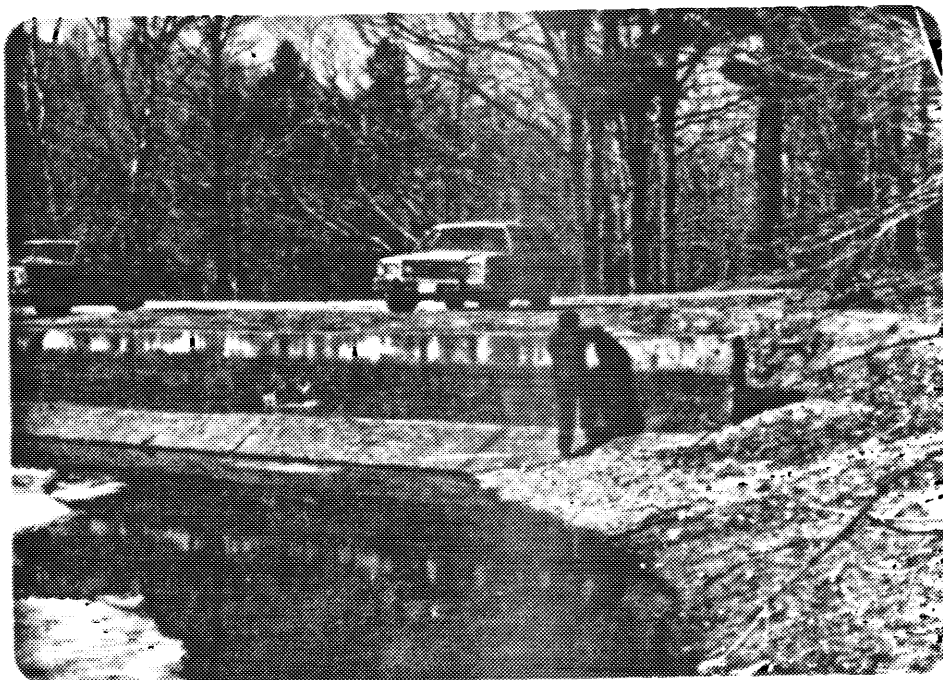
#5. VIEW OF RIGHT ABUTMENT

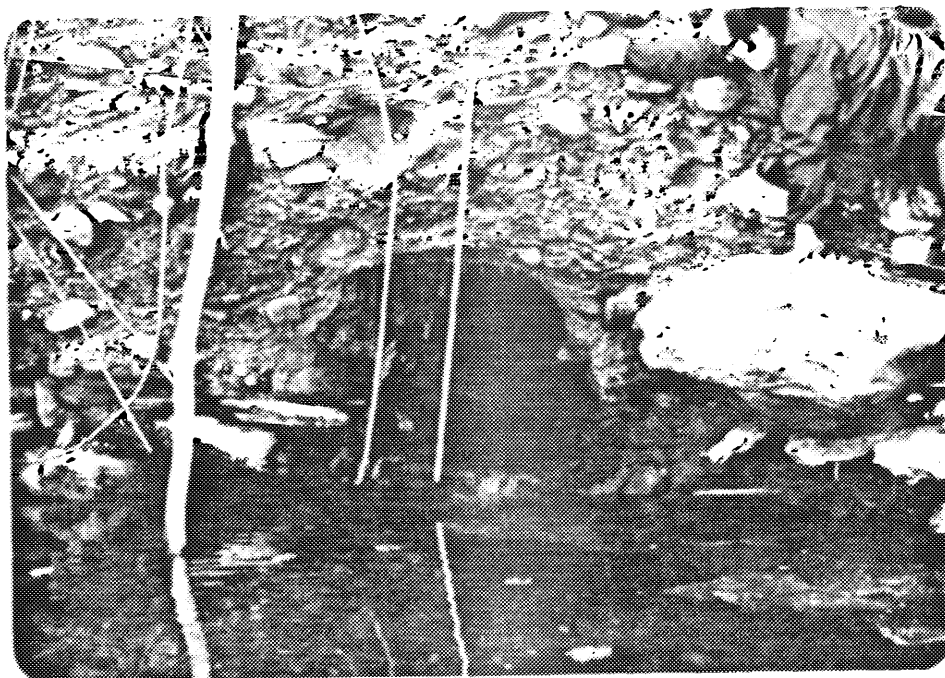
#6. DOWNSTREAM VIEW OF LOW-LEVEL OUTLET

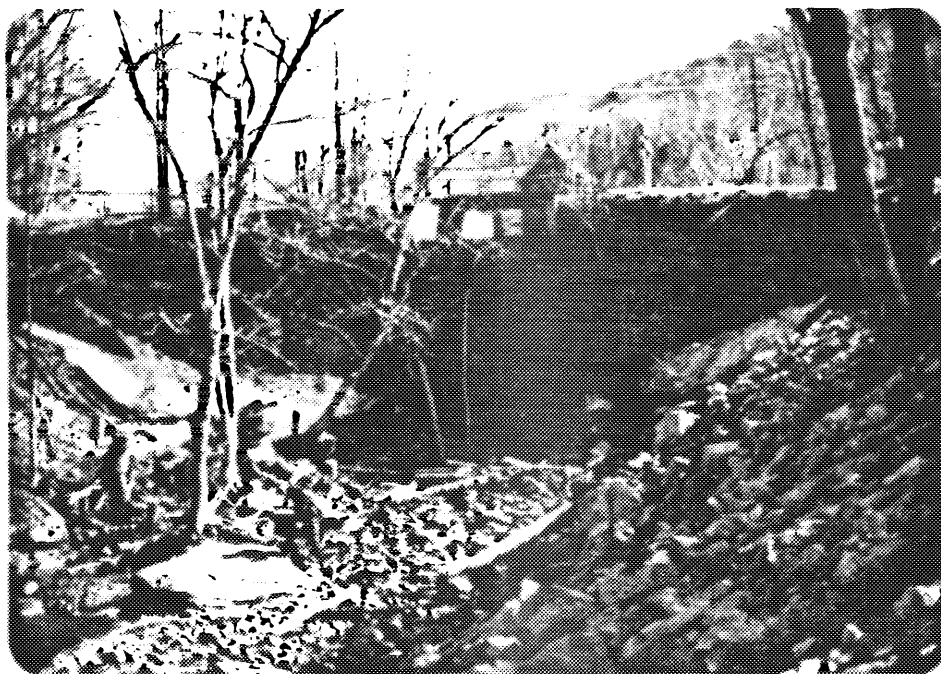
The downstream vertical face is constructed of stone masonry and is in fair condition. Some small trees have been allowed to grow from the masonry (see Photo 7). Photos 9 and 10 show leakage from the left abutment. The cardboard box shown in Photo 9 can also be seen in Photo 8 and indicates the location of the seep in relation to the left abutment. The leakage was found to be 3 feet higher in elevation than the low-level outlet which would indicate the flow is coming through the dam or possibly around the left abutment. The flow was estimated at 7 or 8 gallons per minute.

#7. VIEW OF DOWNSTREAM CHANNEL AND DOWNSTREAM
MASONRY FACE

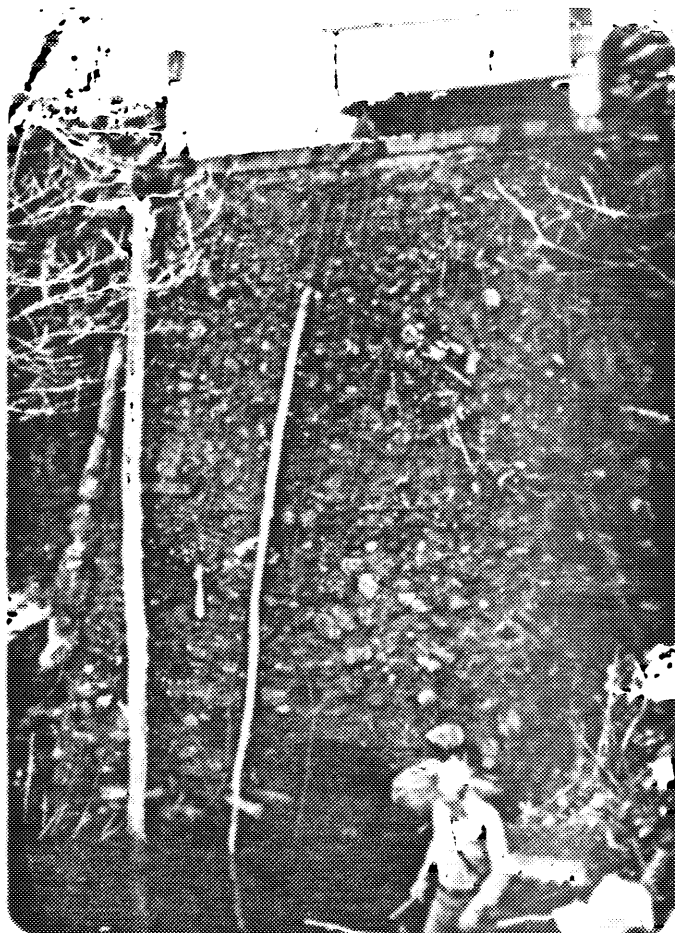
spillway is in very poor condition. As Photo 8 indicates, the concrete facing has been completely scoured, exposing reinforcing rods and large cobbles which were used as aggregate. The photograph also shows the remains of two training walls which have been completely worn away.

Based on the visual inspection, the condition of the Woodward Reservoir Dam was judged as poor. The considerable spalling and erosion of the downstream face of the spillway and the undermining of its foundation endangers the safety of the dam, particularly when water flows through the spillway.

#8. CLOSE-UP OF DOWNSTREAM
FACE SHOWING EXPOSED
REINFORCING AND REMAINS
OF TRAINING WALLS

- a. Repairs of the undermining at toe of the spillway and design of measures to prevent future undermining.
- b. Repair of downstream face of spillway and reconstruction of training walls.
- c. Assessment of the spillway capacity.
- d. Inspection of the outlet conduit and repairs as necessary.

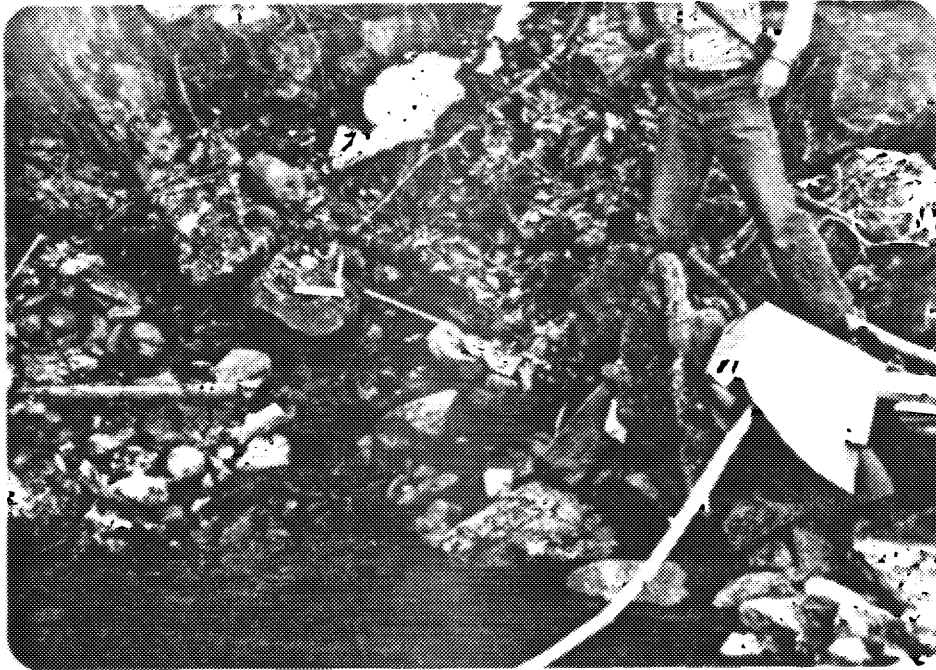
#9. VIEW SHOWING SEEP DOWNSTREAM OF DAM. NOTE CARDBOARD BOX LOCATION IN THIS PHOTO AND IN PHOTO #8.

1. An annual safety technical inspection program should be instituted. It should include monitoring of the seep to the left of the spillway.
2. The routine maintenance of the dam should include repair of eroded areas, patching of minor spalling in concrete and removal of trees growing on the downstream face of the dam and from the discharge channel.
3. A formal warning plan should be prepared.

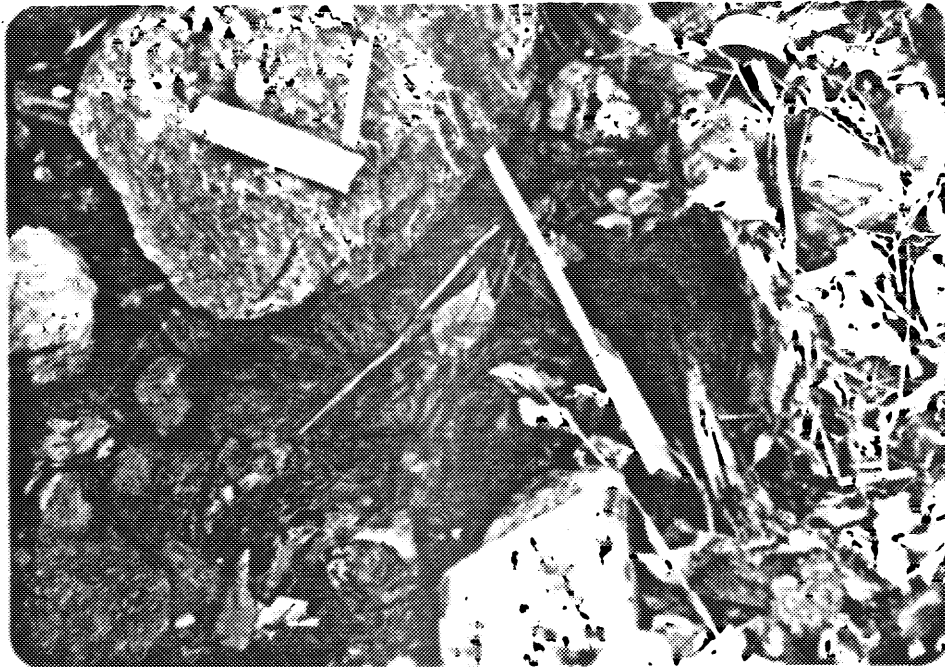
#10. CLOSE-UP OF SEEP
